Manhole Inspection Summary

Manhole # S33Q__020MH

Insp Date: **3/17/08 1:57 PM**

Location Address: **20 cross**

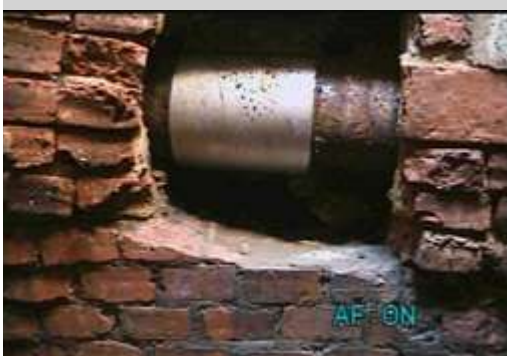
Pipe in wall at 3oclock 5.25 down

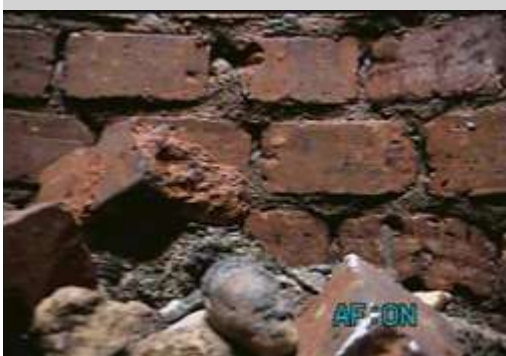
Defect 4

Condition: ☐ Sound ☐ Cracked ☐ Root Intrusion ☐ Deteriorated ☐ Leaks ☒ **Debris**

Bench debris

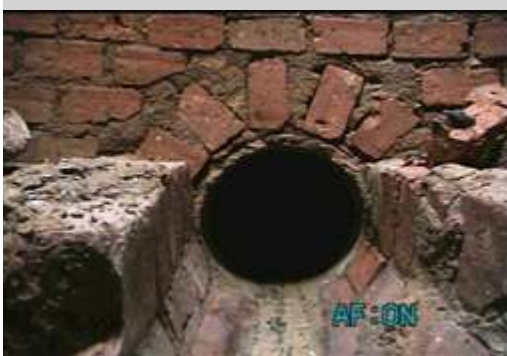
Defect 3

Condition: ☐ Sound ☒ **Cracked** ☐ Root Intrusion ☐ Deteriorated ☐ Leaks ☐ Debris

Channel condition cracked

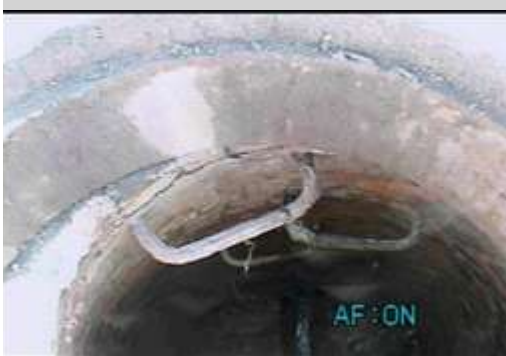
Defect 2

Count: **5** Missing: **0** ☒ **Corroded**

steps

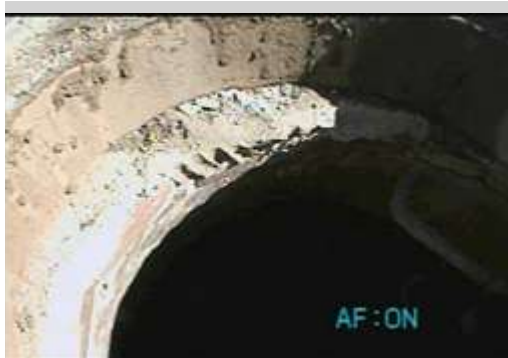
Defect 1

Offset: **3** (in.)

Condition: ☐ Sound ☒ **Cracked** ☐ Root Intrusion ☐ Loose Brick ☐ Deteriorated

offset and chimney cracked

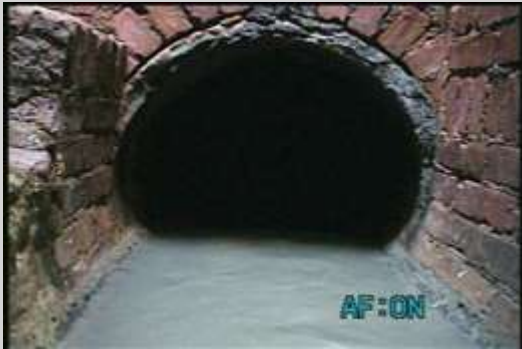
12 O'Clock Outflow

24 in. Circular Gravity Sewer
Pipe Out @ 12 O'Clock

Pipe Material: **Clay** ☐ Pipe Lined

Invert Depth: **9.96** (ft.) Flow Characteristics: **Fast**

Deposits: ☒ None ☐ Mud ☐ Sludge ☐ Debris ☐ Grease

Infiltration: **None** Pipe Seal Cond: **Unknown**

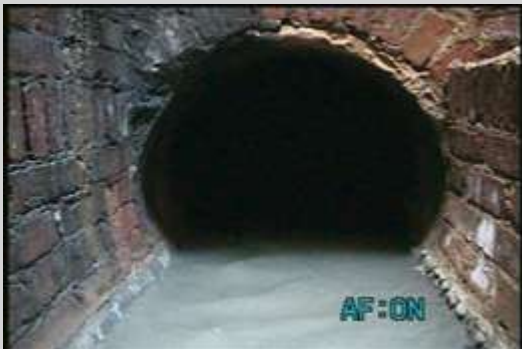
6 O'Clock Inflow

24 in. Circular Gravity Sewer
Pipe In @ 6 O'Clock

Pipe Material: **Clay** ☐ Pipe Lined

Invert Depth: **9.83** (ft.) Flow Characteristics: **Fast**

Deposits: ☒ None ☐ Mud ☐ Sludge ☐ Debris ☐ Grease

Infiltration: **None** Pipe Seal Cond: **Unknown**

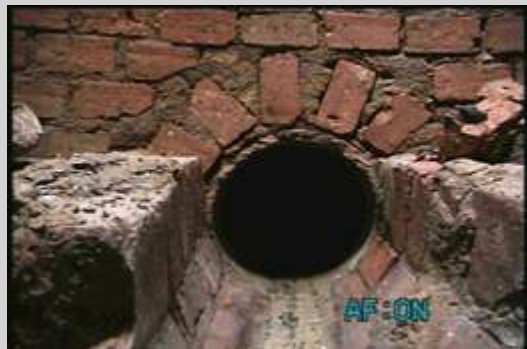
9 O'Clock Inflow

8 in. Circular Gravity Sewer
Pipe In @ 9 O'Clock

Pipe Material: **Clay** ☐ Pipe Lined

Invert Depth: **8.63** (ft.) Flow Characteristics: **None**

Deposits: ☒ None ☐ Mud ☐ Sludge ☐ Debris ☐ Grease

Infiltration: **None** Pipe Seal Cond: **Unknown**
